G-WAC Notes

From the
Project Jay Preservation Group

A News Sheet for those who are interested in the factory registered G-WACs.

November 2021

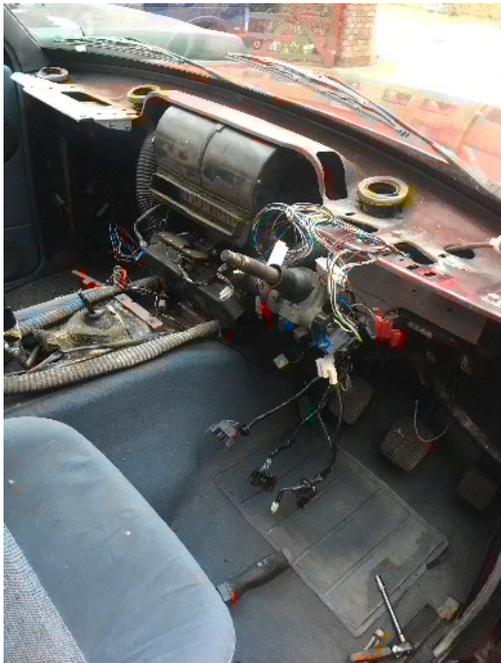
Heater motor on the pre-pro

The heater motor has not run on the slowest speed in G513DHP for some years and stopped altogether at the beginning of this year, but with her being dry stored and only out for shows in the summer I did not repair it.

I did notice that if I accidentally switched the heater on the third position, full speed, I could tell from the drop in the intensity of the ignition light that it was trying to pull power. Leaving it switched on would have made it overheat and perhaps caused a fire.

I decided that it should be fixed before she went into hibernation for the winter. Glen suggested that I take 513 over to him so that he could have a look and fix it for me. I have not yet tackled taking a dash out of a Jay so thought it would be a good idea to let him do the job.

I took her over one afternoon and got a lift home. By 10 o'clock the next day Glen rang to say that he had the heater out and would repair the motor, and it would be ready to collect the next day.

A good job well done and now I have some heat in the car, and more importantly some windscreen clearing, and Daphne does not need a blanket over her legs.

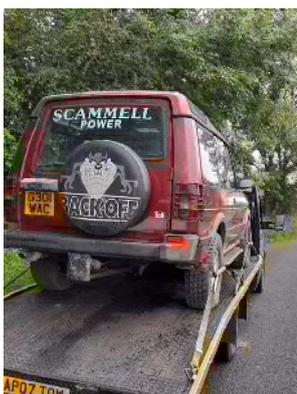
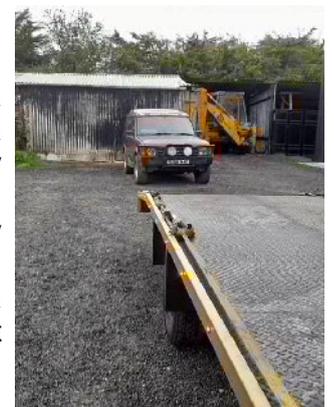
G301WAC has been found

301 has been on our website as 'owner unknown' for a few years now but was recently seen by Ashley in a scrapyards along with some other old vehicles. He promptly bought her.

She has no engine and the V5 shows her as having a cylinder capacity of 2800cc, (diesel) so he is not sure what engine was in her.

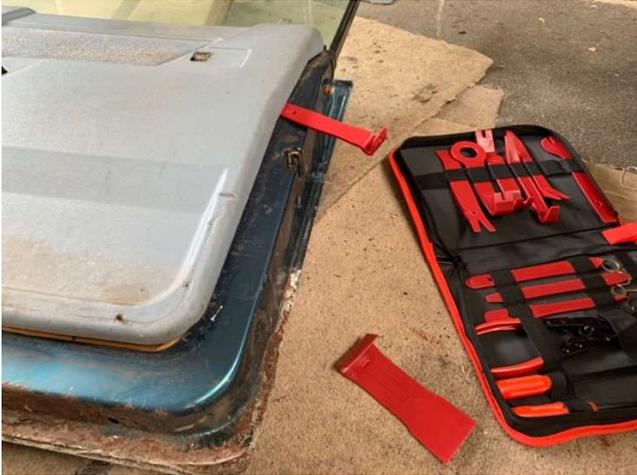
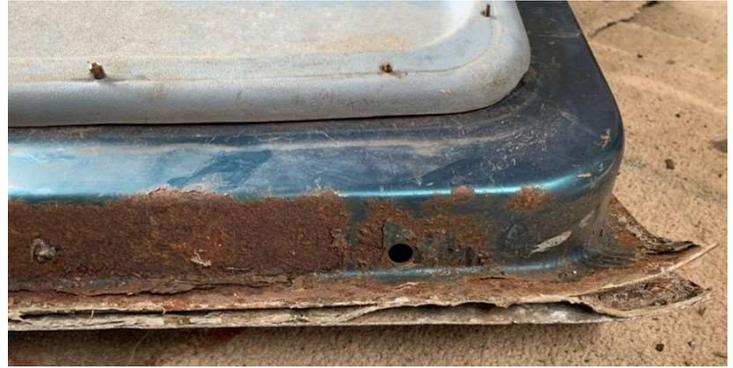
DOOR TRIM

Having cleaned the interior, the doors are the next on the hit list. All three are suffering from edge erosion to the aluminium, with minor tin worm attack to the steel frame, so the plan is to strip the door down and try to repair it with sections of another scrap door bottom. The first thing to remove was the door trim.

Remove the door pull from its mounting brackets.

Remove the interior door release handle surround from the trim panel.

Then work around the trim panel by inserting a trim panel removing tool between the trim panel and the inner door. A set of plastic trim tools makes this task very easy, and they are available on eBay for less than £20 and are useable on all the sections of trim throughout the vehicle, they are a good investment.

Disconnect the two speaker connections from inside the door and remove the trim panel complete with speaker, ashtray, and door bin. A plastic vapour barrier (polythene sheet) covers the door apertures to prevent moisture getting onto the back of the door trim. This is glued to the door and can be released with careful slicing of the glue with a sharp blade.

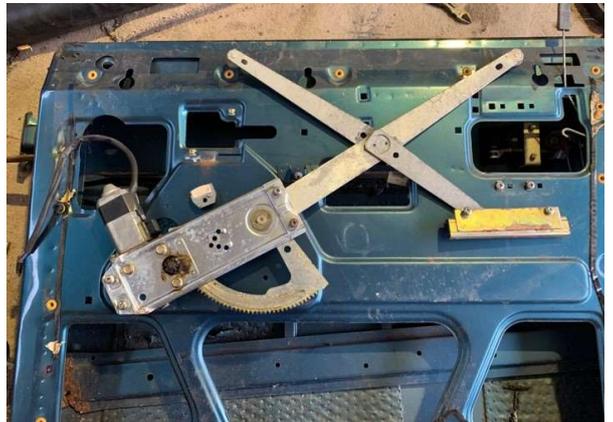
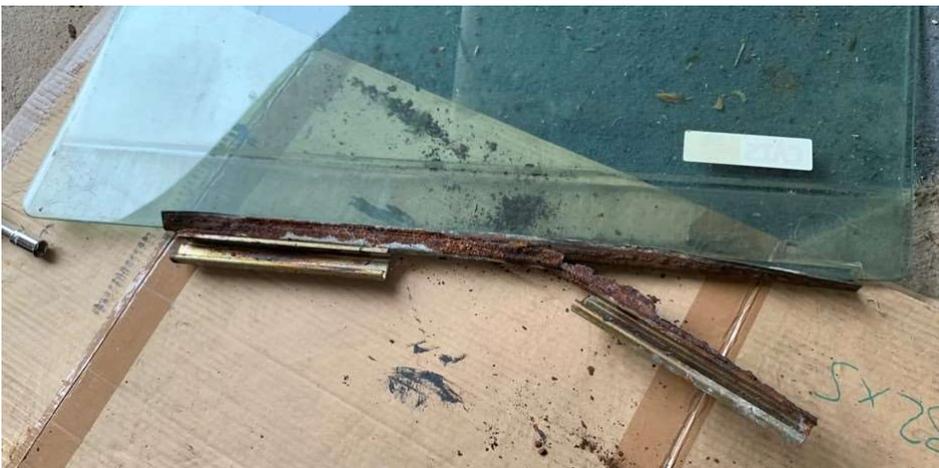
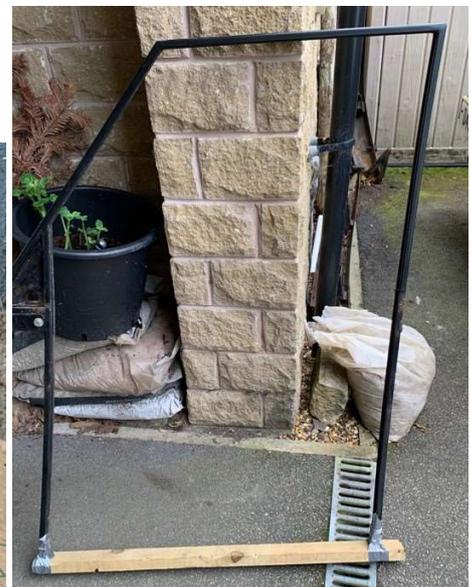
FRONT DOOR GLASS AND REGULATOR

With the window in the fully closed position tape the glass to prevent the window from dropping down. Remove the window lift motor and the window regulator screws. Remove the two screws holding the lower window lift channel and slide the channel off the stud. As you can see the lower window lift channel was rotten. If it fails it can result in the window falling into the door, but it is still available to buy.

With the window lift mechanism released, remove it from the lower centre opening in the inner door panel. Remove the exterior driving mirror and seal from the top of the door panel. Remove the bolts which secure the window surround from the door frame.

Lift the door glass frame complete with glass out of the door, then slide the glass out of the door frame channel. The glass frame is quite flexible, so I taped it to a length of wood for support.

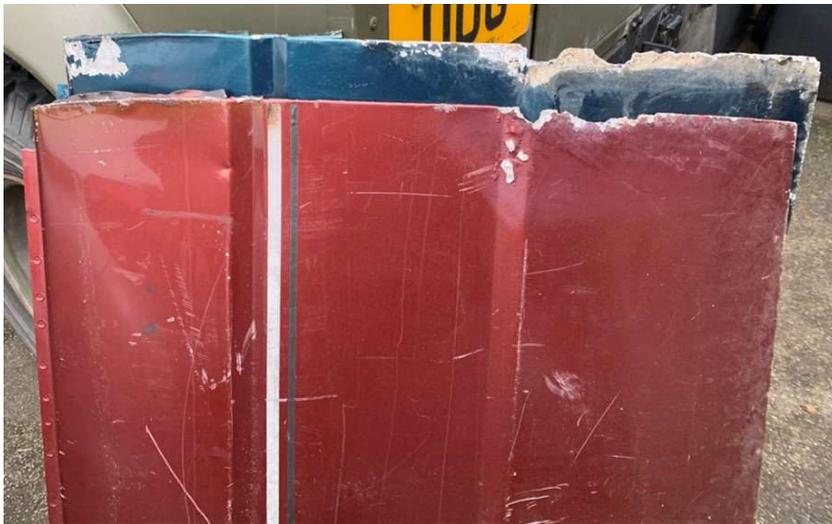
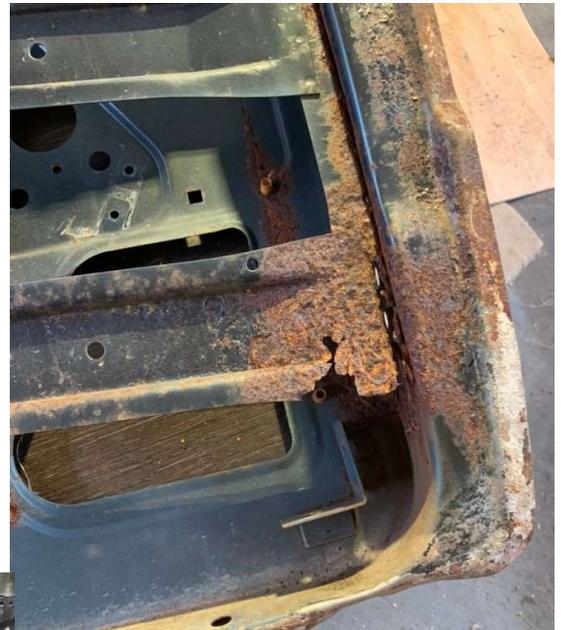
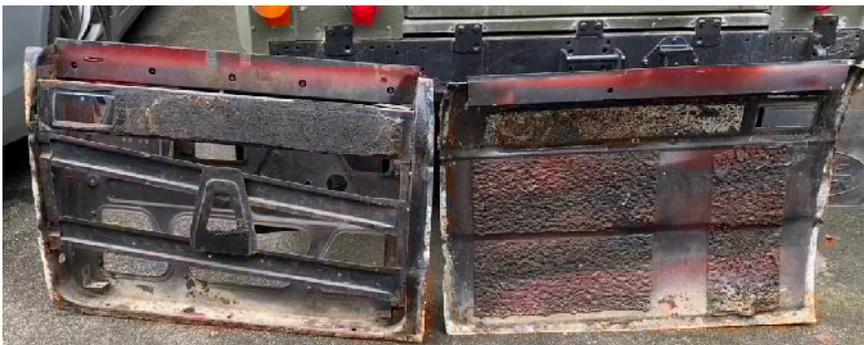
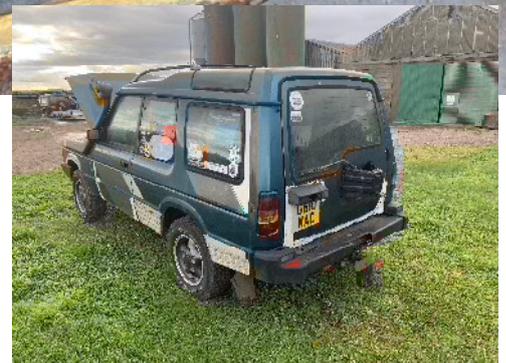
With the lower door stripped out, I peeled back what was left of the wrap around fold of the aluminium skin and removed it from the steel frame. The skin was glued to the frame with what looks like a sound deadening paint, but came away fairly easily with a thin blade.

I plan to cut an old skin into strips and try to weld, glue or braze them to the original skin to replace the corroded sections. In the meantime I will repair the steel inner door. **To be continued.**
